BIOENGINEERING / RIPARIAN HABITAT RESTORATION
SHEEP CREEK ROAD KM 5.5

The Provincial Emergency Program
through the Ministry of Transportation and Highways of the Central Kootenay District.
Contract # 310 LM 7544

Pierre Raymond Forest Technologist

July 16, 2001

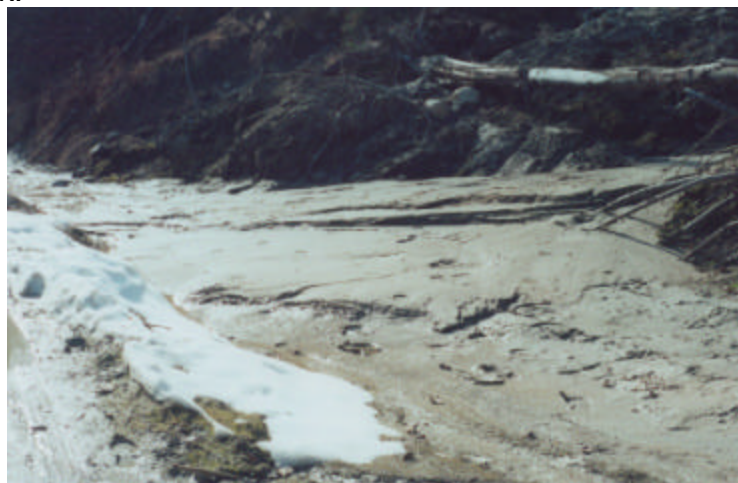
Plate # 1, Mud/earth flow into ditch spring 2001

The initial debris slide and earthflow occurred sometime between the fall of 1998 and the spring of 1999 (source MOTH, Creston Office). The cause of the failure is not clear. It may be related to old mining-activities, which altered the drainage patterns on the area upslope. Inspection of the area immediately upslope did not reveal obvious drainage concentration. Removal of toe support in the construction of the road and subsequent ditch cleaning is likely to have been a factor contributing to the failure.

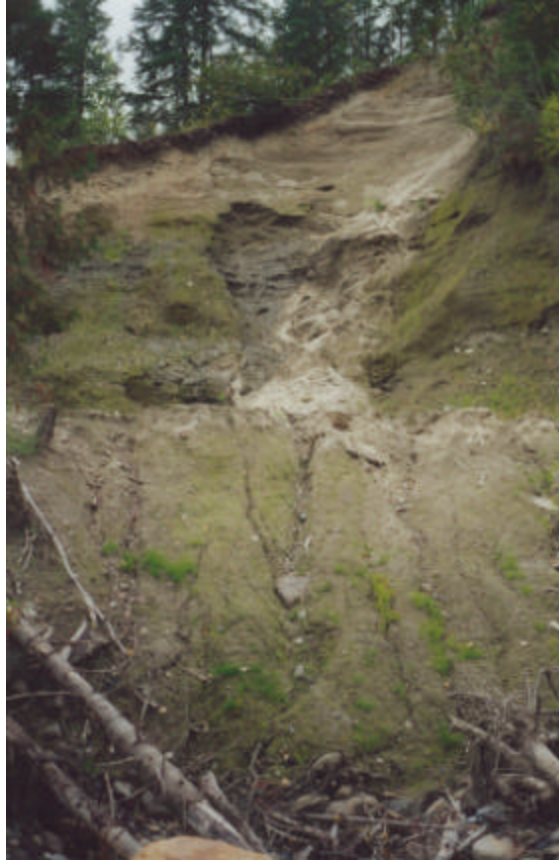
The main failure, designated site 1 in this report, is a debris slide/earth flow, which occurred above the Sheep Creek road and failed/flowed onto the road. Approximate dimensions of the failure are 30 m. wide by 46 m. length by a height at the failure headwall of about 10 metres. Gradients on the slide face range from 80 to 150% and from 30 to 60% on the debris at the toe of the slide. The material is primarily glacio- lacustrine inbedded silt and sand with some clay. In places the materials are varved. (see plate #2). The glaciolacustrine materials are overlain by glaciofluvial sand and gravel. The glaciofluvial materials are dry and well to rapidly drained. The galciolacustrine materials are poorly drained and include extensive areas of seepage. The water table is perched on silt and clay layers in a number of locations.

At the site below the road, designated site 2 in this report, is a failing bank where material from the debris slide has been sidecast directly into Sheep Creek. The material on the failing portion of the bank, which is about 31 m long by 10 m wide, has sloughed and ravelled into the creek. The bank gradients are 80 to 100%.

Plate #2; Site 1 and 2, Fall 2000, prior to rehabilitation

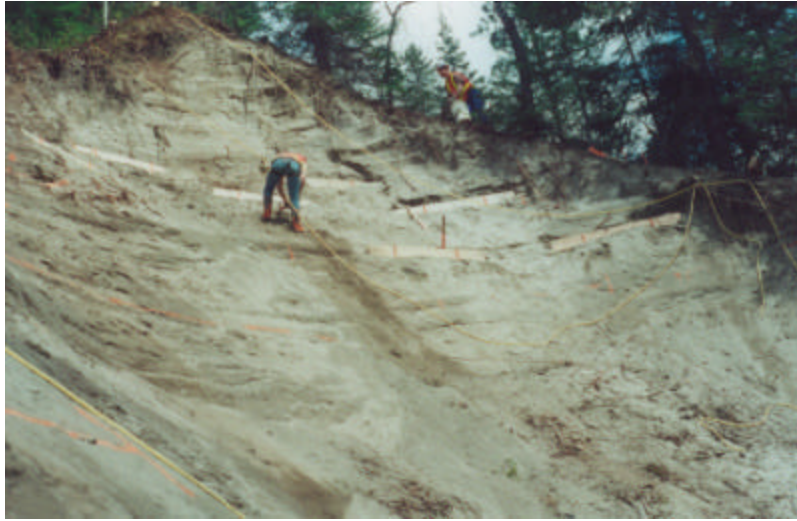
Plate #3; Site 1, Modified brush layers in sandy area

Based on the field visit, site characteristics, and consultation with D. Polster and D. Putt, the following prescription and layout was applied to the site. Modified brush layers (25) were installed in the sandy area at the upper section of the site. These structures should stop the ravelling created by the steepness (100 to 150%) of the sands and gravels and help establish vegetation (see plate #3). The use of contour fascines (see plate #4) and drain fascines in combination with central live pole drains system should help control the excess surface water and seepage on the site (see plate #5). As these structures are partially buried they should be more resistant to the summer drought. These structures will also act as a sediment trap to catch flowing sediment as the woody vegetation sprouts from the fascines. In the area directly above the ditch line the combination of live fascine bundles (25 cm in diam.) placed on a brush layer of 1.0-m. cuttings (see plate #6) should provide support to retain materials and prevent sloughing into the ditch.

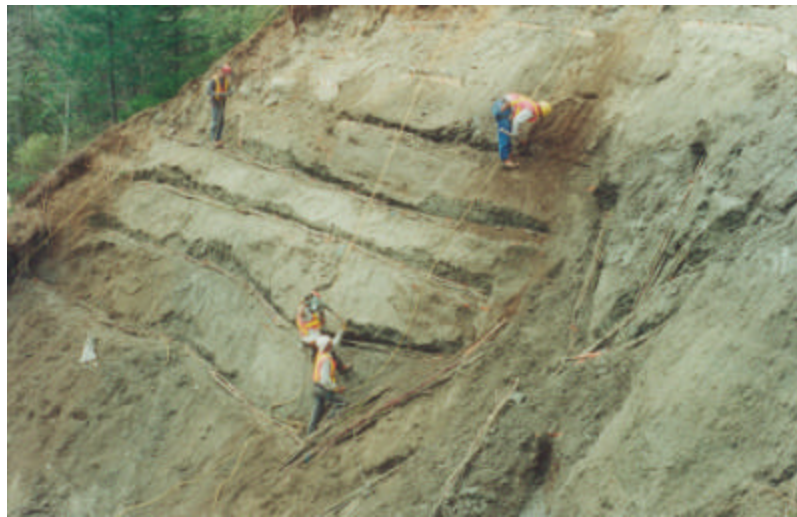
Plate #4; Site #1, Contour fascines and modified brush layers

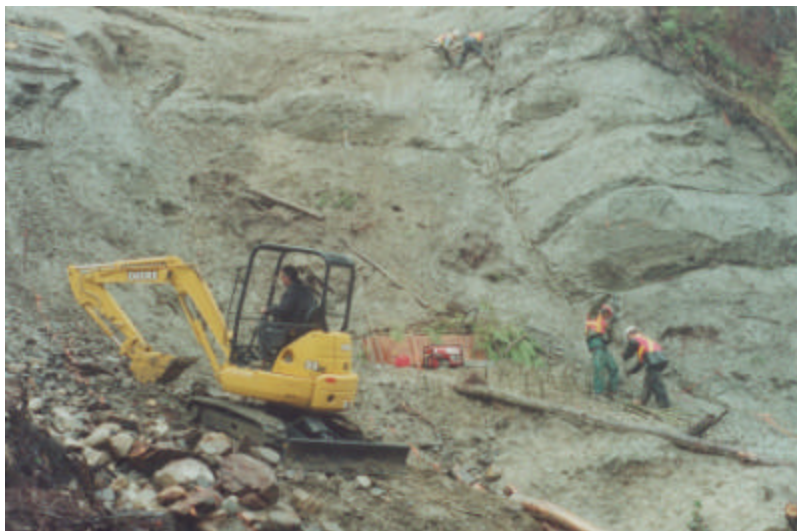
Plate #5; Site #1, Live pole drains/drain fascines and live stakes

Pieces of semi rotten logs were placed on top of the cuttings at the base of the brush layer to provide organic materials and oxygen to enhance root growth. Live stakes (480) were prescribed at the bottom of the site above the road within the debris in the slide runout zone (see plate #5). The root mass produced from the live staking should intertwine together and help stabilize the accumulated materials. Wattle fences were also installed above the live pole drains to retain materials and prevent them from falling and obstructing the drains. Hydro seeding of grasses and legumes mix and container type Sitka mountain alder seedlings were also prescribed to reduce surface erosion and increase the slope stability.

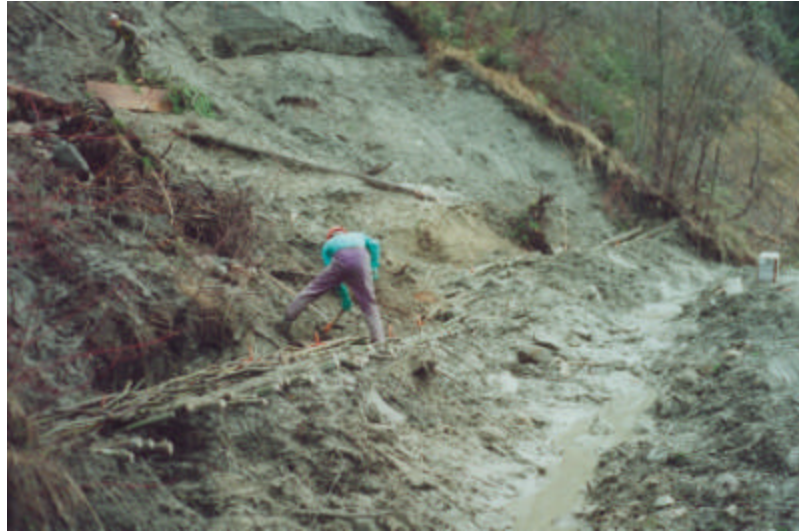
Plate #6; Site #1, Brush layer and contour fascines installations

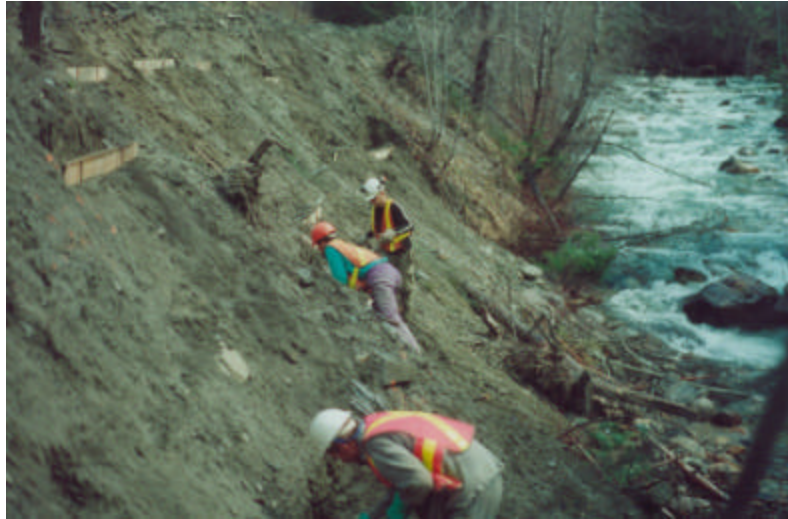
Plate #7; Modified brush layers installations below road

Based on the field visit, site characteristics, and consultation with D. Polster and D. Putt, the following prescription and layout was carried out on the site. The site has a composite of the materials up slope (site 1) which have been sidecast (gravel, sand and silt). The planting directly below the road grade of a combination of live fascine bundles (25 cm in diam.) placed on a brush layer using 0.8-m cuttings should provide support to retain and hold the unstable sidecast material. Modified brush layers (16) were installed in a staggered pattern, between the road and the high water mark directly below the contour fascines/brush layer structure. These modified brush layers structures should stop the ravelling and help establish vegetation (see plate #7). Hydro seeding of grasses and legumes mix, in addition to container type Sitka mountain alder seedlings, was prescribed to reduce surface erosion and increase the slope stability.

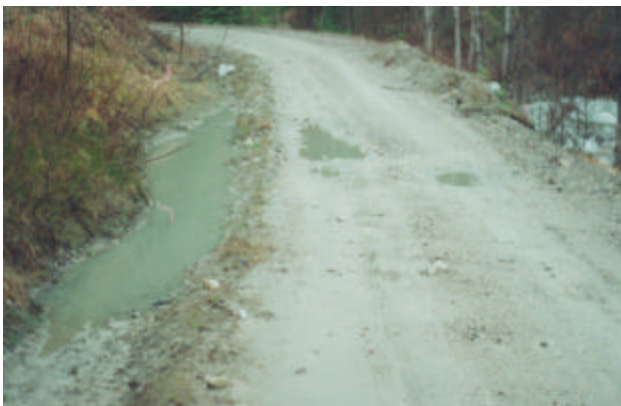
**Plate #8; East of site #1,
Prior to culvert installation**

A mini John Deere excavator was used to conduct minor machine work. The ditch line was cleared of debris and soil and one additional metal culvert (300 mm. In diam.) with plastic flex pipe to carry water down the bank was installed, 21 meters west of an existing metal culvert. The intakes of the existing and new culvert were armoured to prevent bank sloughing and plugging of the culvert (see plate #8,9). As well the excavator was used to excavate the lower portions of the live pole drains system and both the contour fascines/brush layer structures at the toe of site 1 and at the top of site 2.

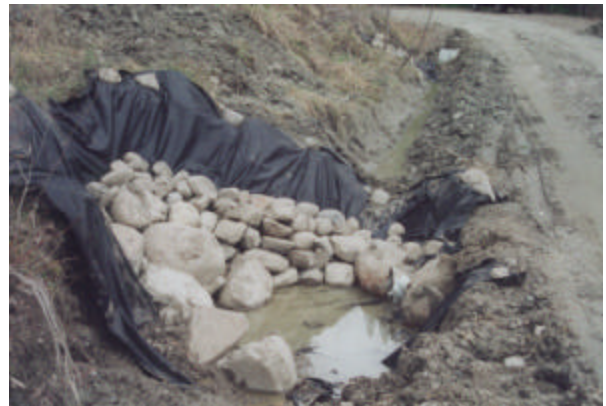
**Plate #9; East of site #1,
Installed culvert and armoring**

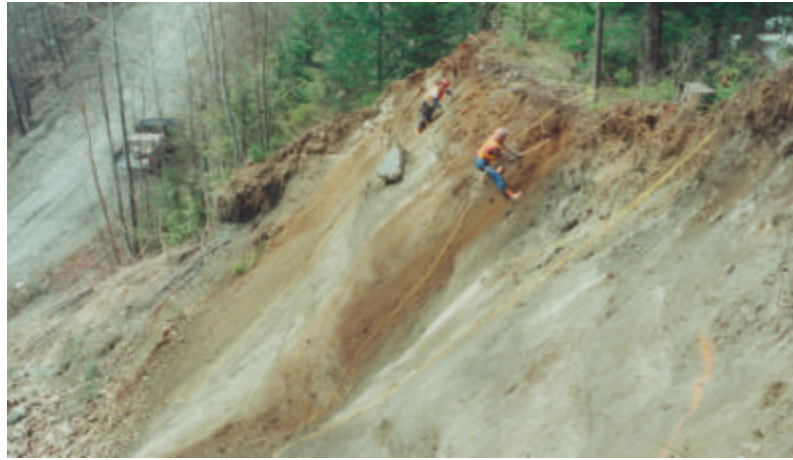
Plate #10; Site1, Site preparation, rock scaling

All wildlife / dangerous trees were assessed by a certified assessor and felled as per W.C.B. regulations. Smaller trees and shrubs were felled above the headwall scarp of site 1 to prevent wind fall which might destabilize the scarp. The scarp was shaved using hand tools to reduce slope angle. Cables were installed in appropriate locations to secure workers for use of climbing harness while installing structures and carrying out on site work. Both sites were rock scaled to remove all loose rock and debris and ensure safe work sites (see plate #10).
